October 1945 as
Memorandum Report A5J19a

A FLIGHT INVESTIGATION OF THE ICE-PREVENTION REQUIREMENTS OF
THE UNITED STATES NAVAL K-TYPE AIRSHIP

By Wesley H. Hillendahl

Ames Aeronautical Laboratory
Moffett Field, California

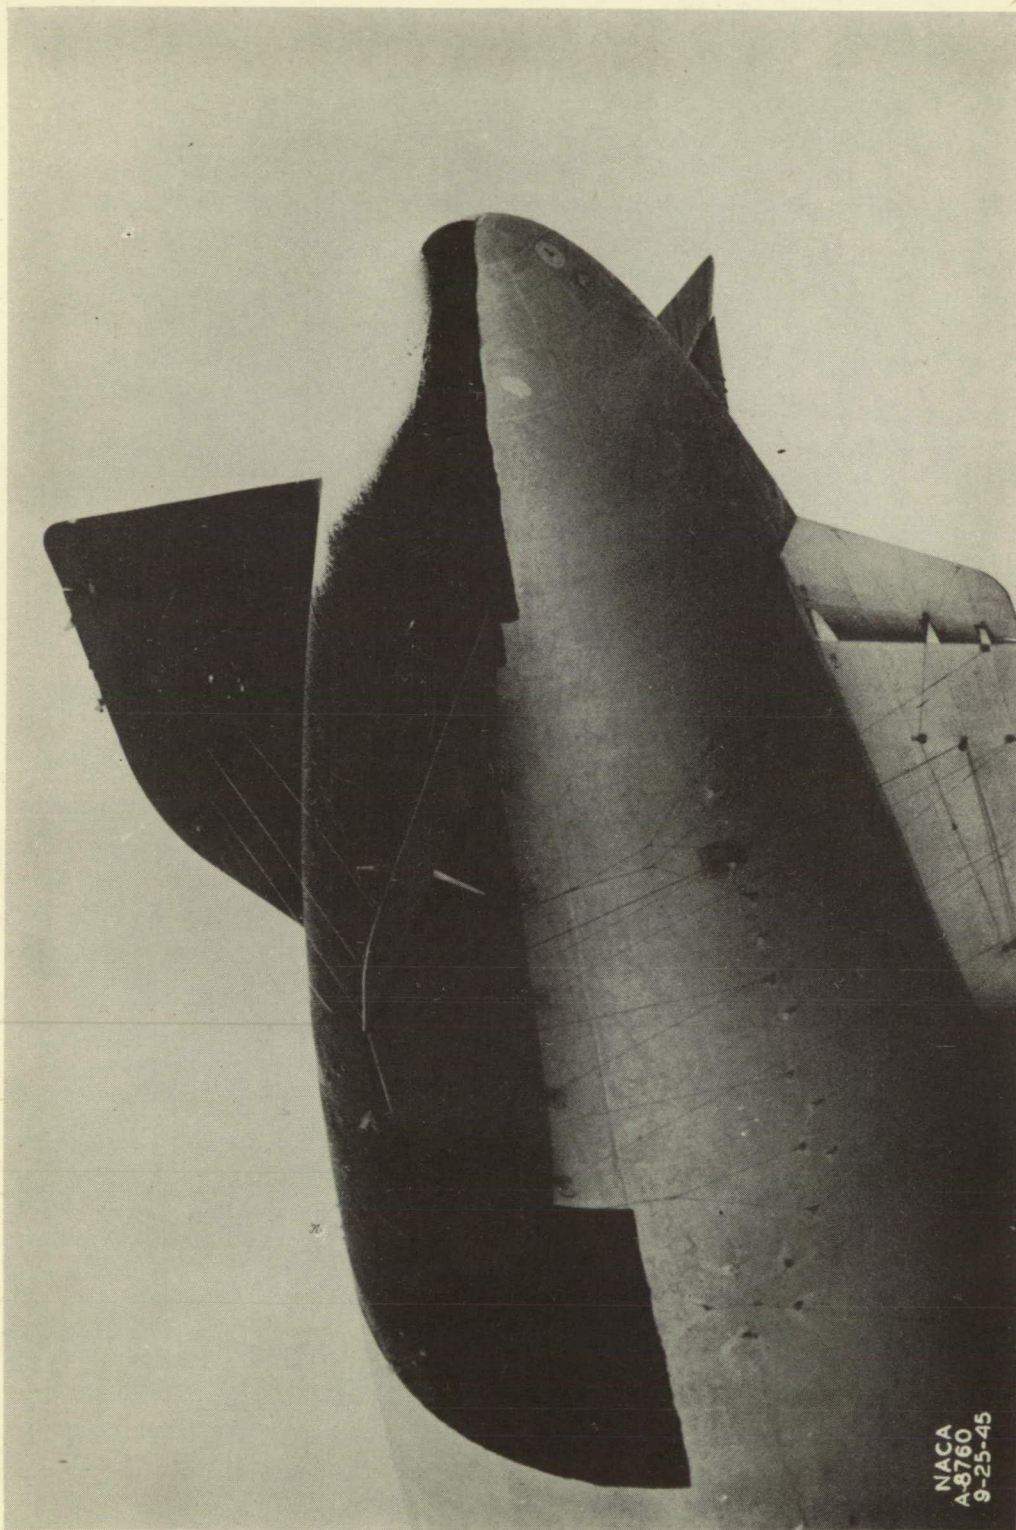
The following pictures were taken while the K-24 was being docked. Figure 30 shows the thickness of the ice which had accumulated on the oil-cooler strut. The ice remaining on the car windshield, spotlight, and electric humidity transmitter can be seen in figure 31. Figures 32, 33, and 34 show the snow remaining on the bow and stern of the envelope and on the upper fin brace wires. Figure 35 shows the general clear appearance of the envelope immediately after landing.

If, in estimating the weight of the snow at the stern of the envelope, it is assumed that the density of the accumulation is one-third that of water and that it averages 2 inches in thickness, its weight would be about 500 pounds. Only when flying at very low altitude would such a load present a hazard to the airship. If, under this condition, the snow were to slide off, a rapid change in elevator angle would be required to compensate for the change in trim without loss of altitude. While the second largest accumulation of snow occurred on the bow of the envelope, it was not extensive enough to have any noticeable effect on the airship.

Figure 33.- Residual ice and snow on the stern of the K-24 airship after landing,
Mar. 22, 1945.

4. While ice and snow accumulate at the bow and stern of the envelope during flight, the present tests indicate that ice-prevention equipment is desirable but not essential in these regions when flying in wet snow.

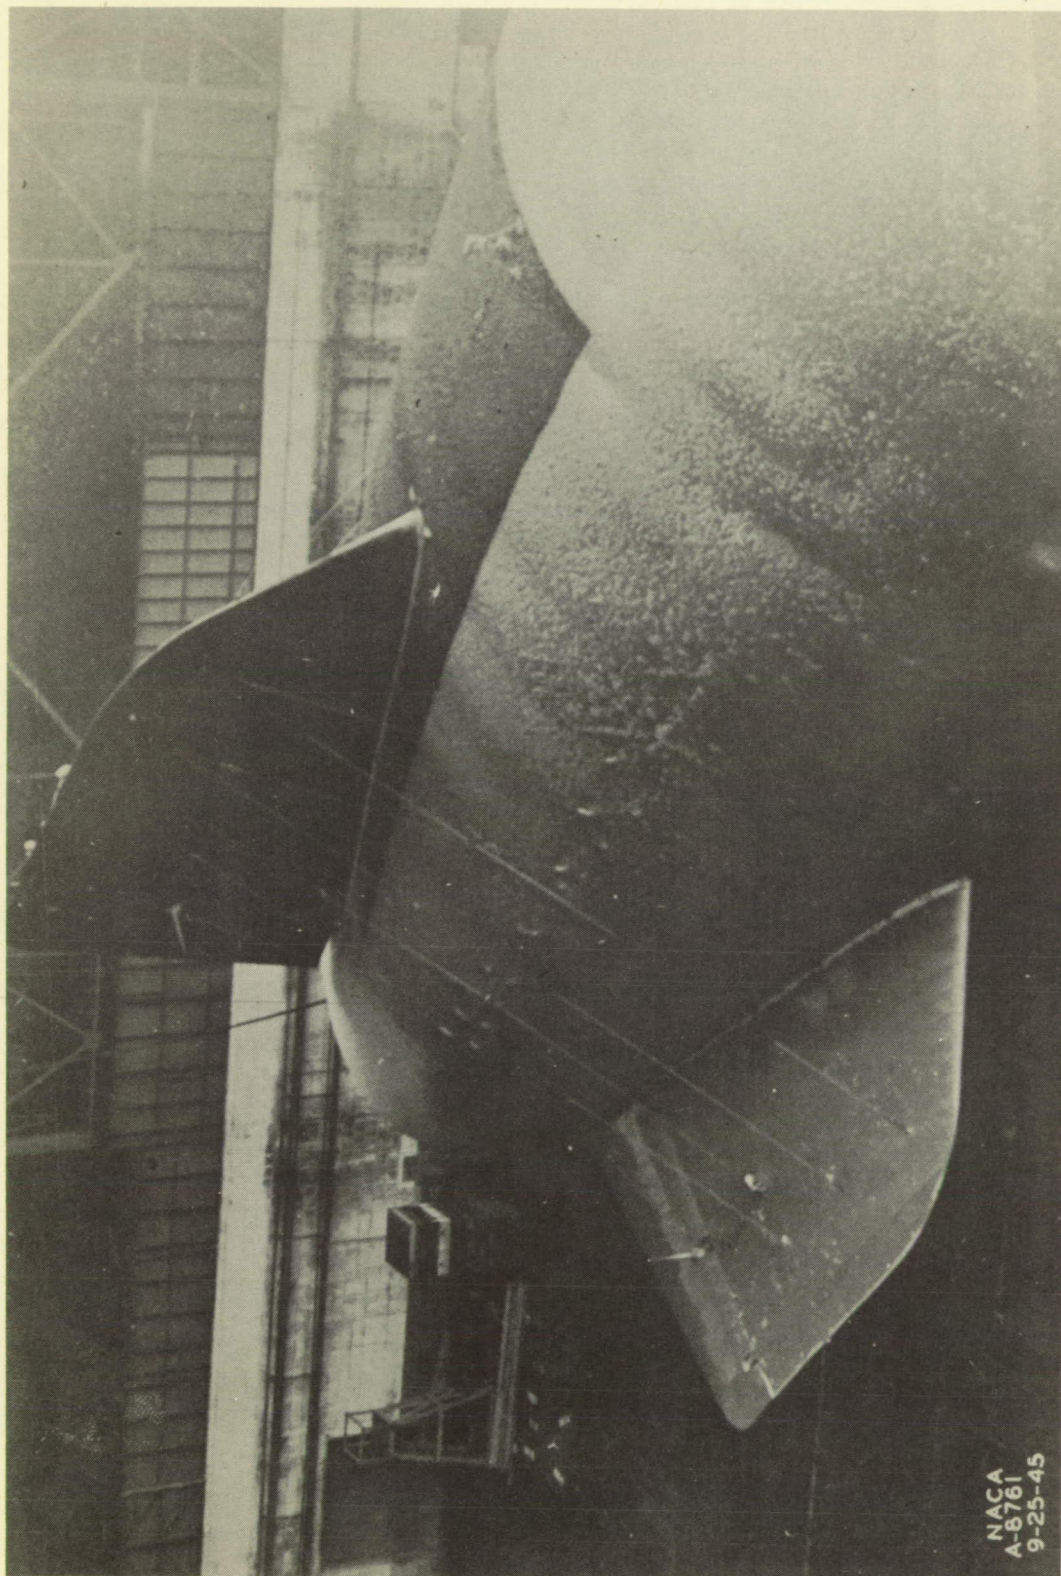
Figure 34.-- Snow on the top of the K-24 airship envelope after landing, Mar. 22, 1945.

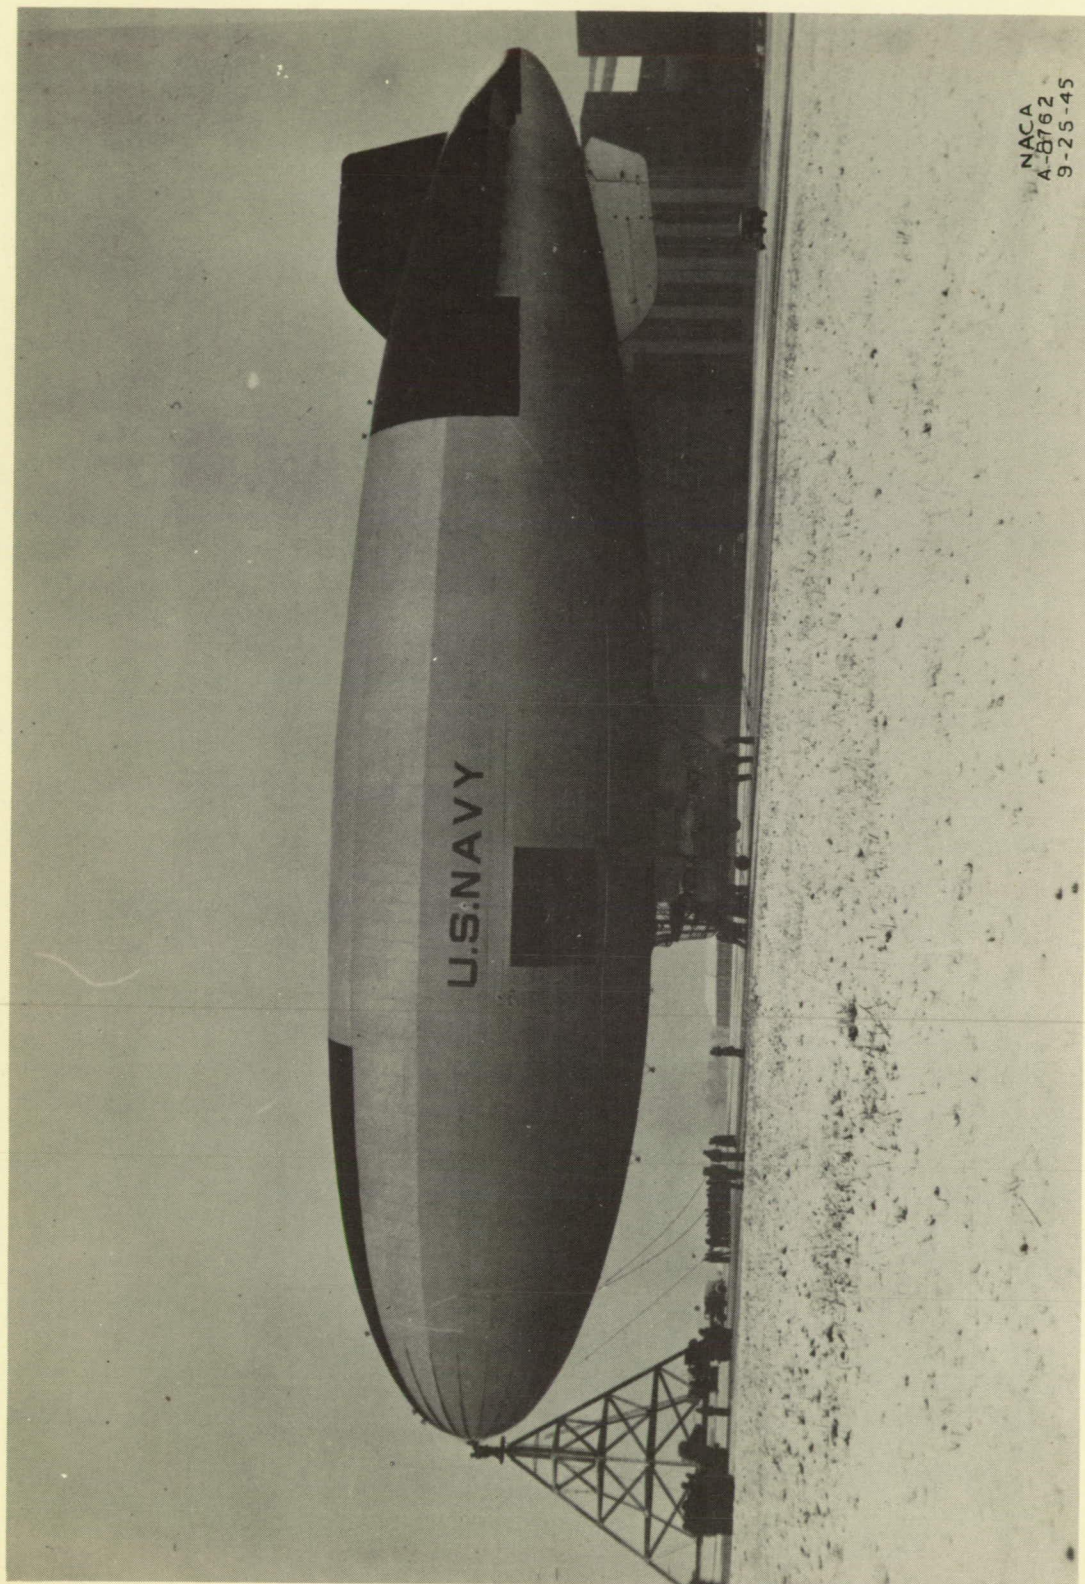
Figure 35.-- The K-24 airship after landing, Mar. 22, 1945.
